CITY of SAN DIEGO
WORK REQUEST FOR ASBESTOS & LEAD MANAGEMENT PROGRAM

Facility Name/Address: SDFD TRAINING FACILITY

Surface Mount Audio Visual Equipment in Existing Classroom in Building 89C, 1608-2580 KINCAID RD
Ceil

ASBESTOS & LEAD MANAGEMENT PROGRAM
HOMOGENEOUS MATERIALS FORM

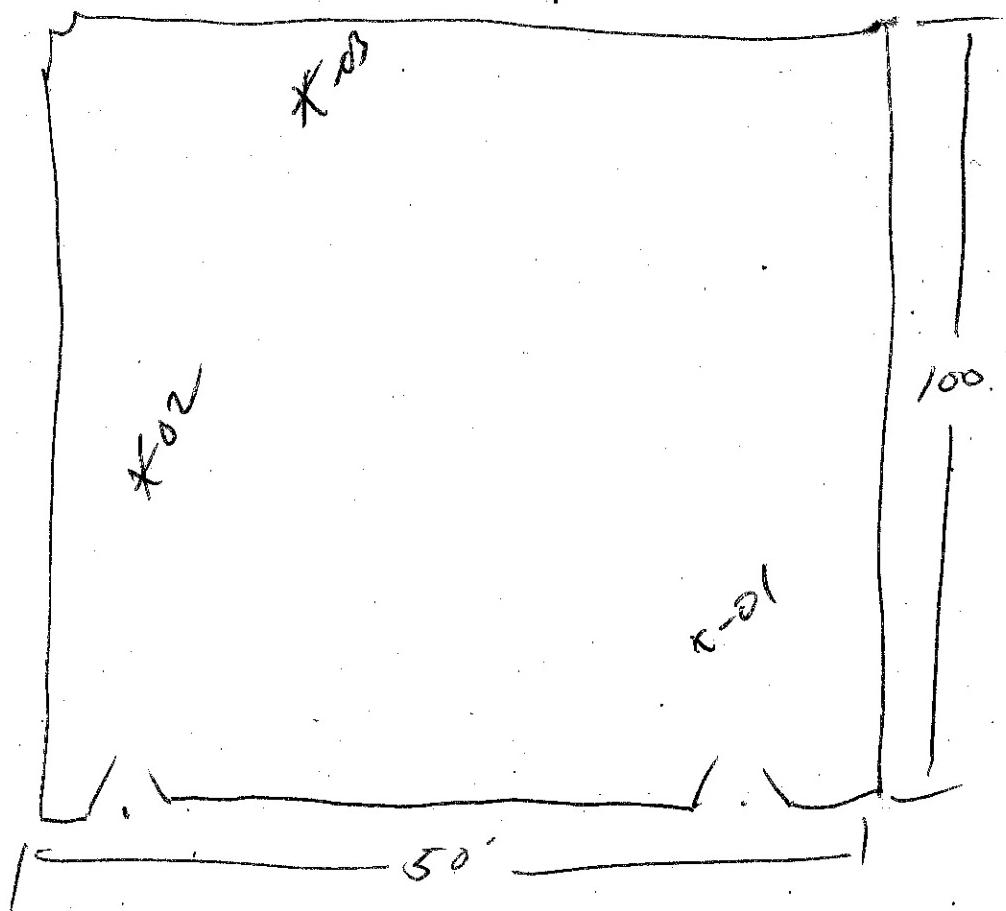
DRAWING (SHOW SAMPLE LOCATIONS)

AN INSPECTION WAS PERFORMED ON 6-25-08. THE
CEILING TILES WERE TESTED FOR ASBESTOS. NO
ASBESTOS WAS DETECTED.

PROJECT# <u>6234</u>	FACILITY# <u>10209</u>	FACILITY NAME <u>BODG 608</u>
INSPECTOR <u>Brand</u>	DATE <u>6/25/08</u>	QUANTITY <u>50'x100'</u>
MATERIAL DESCRIPTION <u>2x4 Ceiling Tile</u>	FRAMABLE? <u>Y</u>	
ASSESSMENT NUMBERS	SAMPLE NUMBERS <u>-01 -02 -03</u>

Classroom

Crew will run electric through existing conduct, ~~but~~ but
will need to access above ceiling
Bldg Built in mid(1980's)
no paint impact - no core above CT - Fibreglass insulation above
core
